# Manhole Inspection Summary

Manhole # S15CC2011MH

Insp Date: **7/26/06 11:03 AM**

**Location** Address: **2100 UFFINGTON RD**

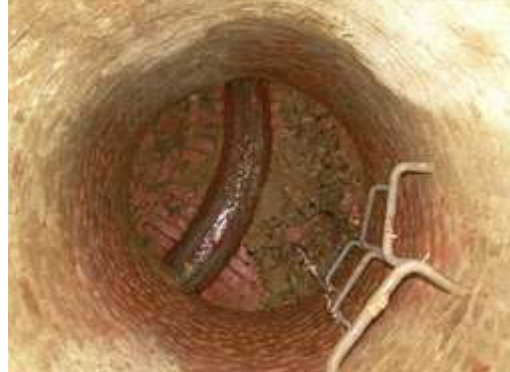
Top View

Evidence of surcharge - Bench debris.

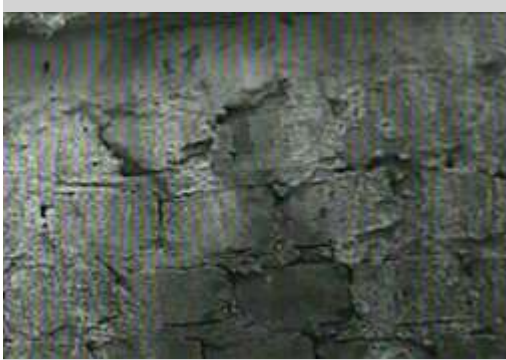
Defect

Adjustment and Corbel deterioration and infiltration.

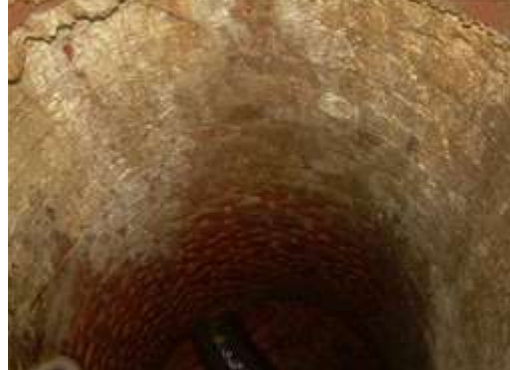
Defect

Adjustment, Corbel and Barrel infiltration.

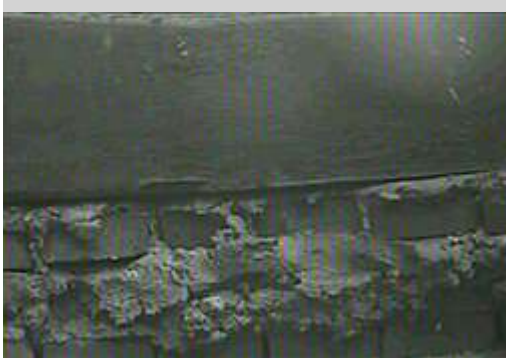
Defect

Frame leaks. Adjustment deterioration and infiltration.

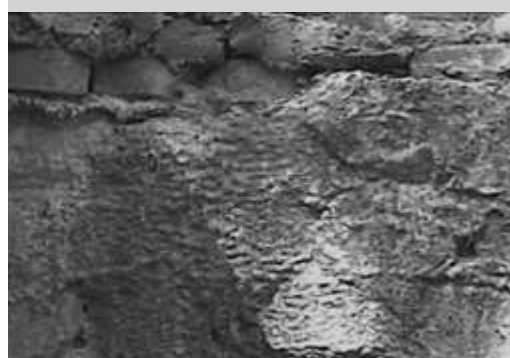
Defect

Corbel deterioration and infiltration.

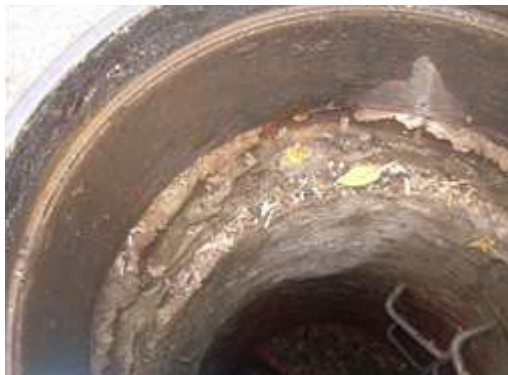
### Defect

Frame leaks. Frame offset. Adjustment, Corbel and Barrel infiltration.

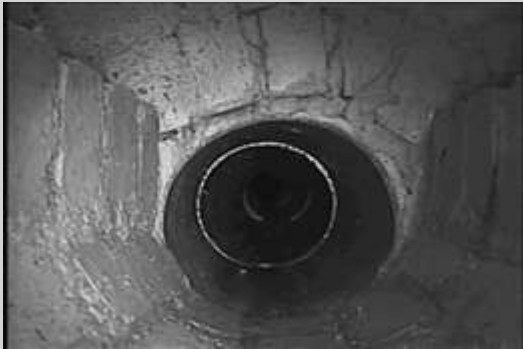
### 8 in. Circular Gravity Sewer Pipe Out @ 12 O'Clock

Infiltration: **Evidence** Pipe Seal Cond: **Cracked**

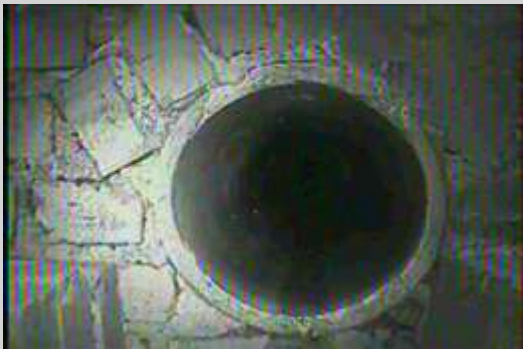
### 8 in. Circular Gravity Sewer Pipe In @ 7 O'Clock

Infiltration: **Evidence** Pipe Seal Cond: **Cracked**
